# KANSAS CITY BROWNFIELDS COALITION

1017, 1021 & 1023 W. 17th; Mattie Rhodes Arts Center

April 2022

## SITE DIAGRAM

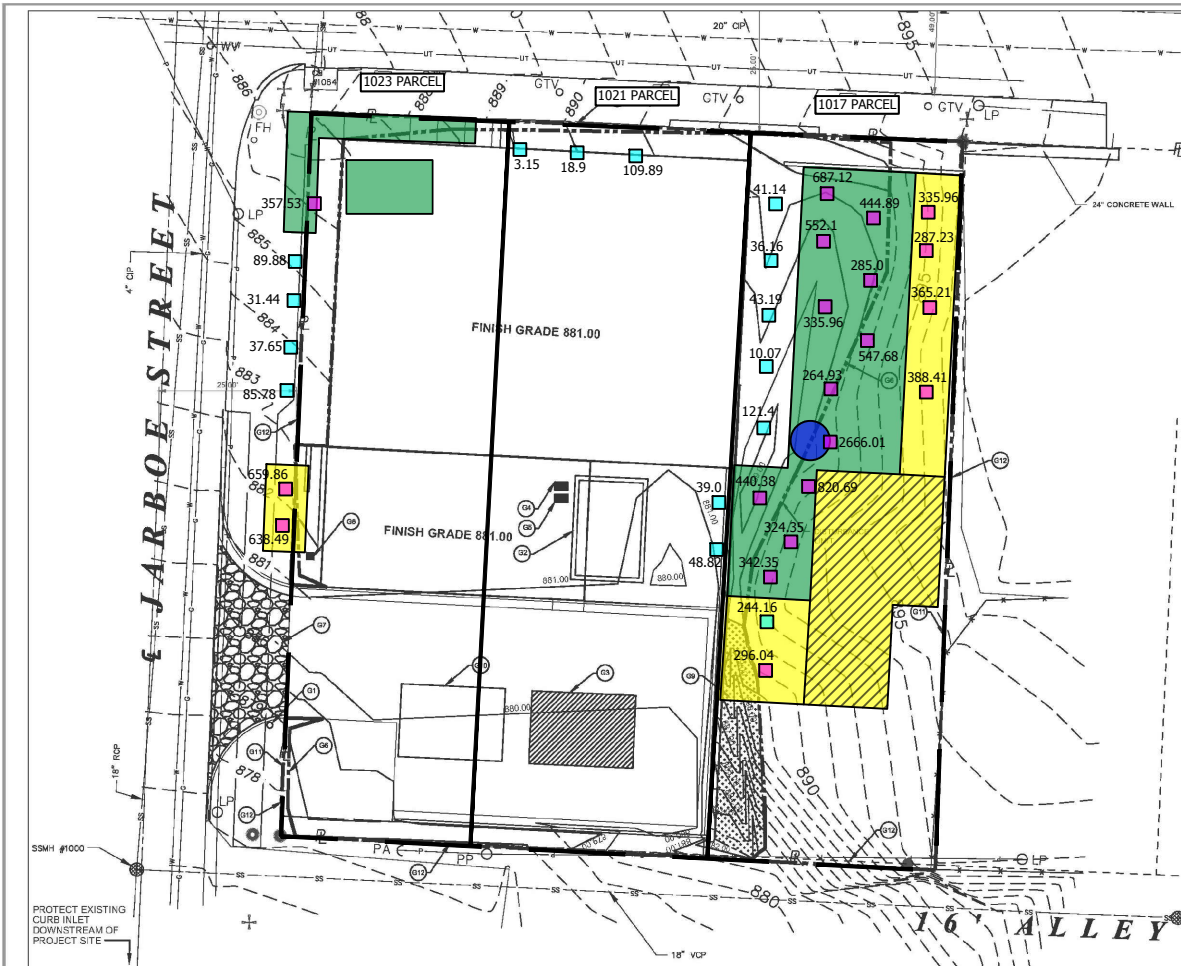
FIGURE

MATTIE RHODES COMMUNITY CENTER  
 1017-1023 W. 17TH STREET  
 KANSAS CITY, JACKSON COUNTY, MISSOURI

**Remediation:** What started as a limited removal of “hot spot” lead contamination in surface and subsurface soils ended up removing far more in volume of contaminated

materials than originally anticipated. The cleanup was innovative in that the grading plan and remediation plan were integrated together so that the environmental contractor, not the civil contractor, was the one who encountered the unanticipated contaminated fill and managed the cleanup. This contractual posture was critically important when the conditions were discovered. The expertise, creativity and dedication of MRC's contractor EWI, working together with MRC, the city's QEP and MDNR, allowed the grading and cleanup work to adapt and continue towards completion while remaining compliant with the BVCP process so that it could earn a Certificate of Completion.

When promptly notified, MDNR responded quickly to the changed conditions with guidance and approvals to allow appropriate modifications to the remedial action plan. Site redesign also allowed construction of a green infrastructure feature to naturally retain stormwater, and when even more contaminated fill was encountered during final grading for foundations and the green infrastructure, MDNR was again promptly informed and provided further guidance and approval to continue implementation of the modified RAP. The attached figure shows the areas of contamination discovered after remediation and grading per the remedial design was conducted. Additional excavation was performed and confirmation samples obtained for MDNR review and approval.
